Investigation of the UH-60 Main Rotor Spindle Assembly Retaining Rods P/N 70102-08102/-103

ARL-TR-1585

January 1998

The purpose of this investigation was to determine the root cause of the differences seen in the fatigue test data of UH-60 main rotor spindle assembly retaining rods from three different vendors.

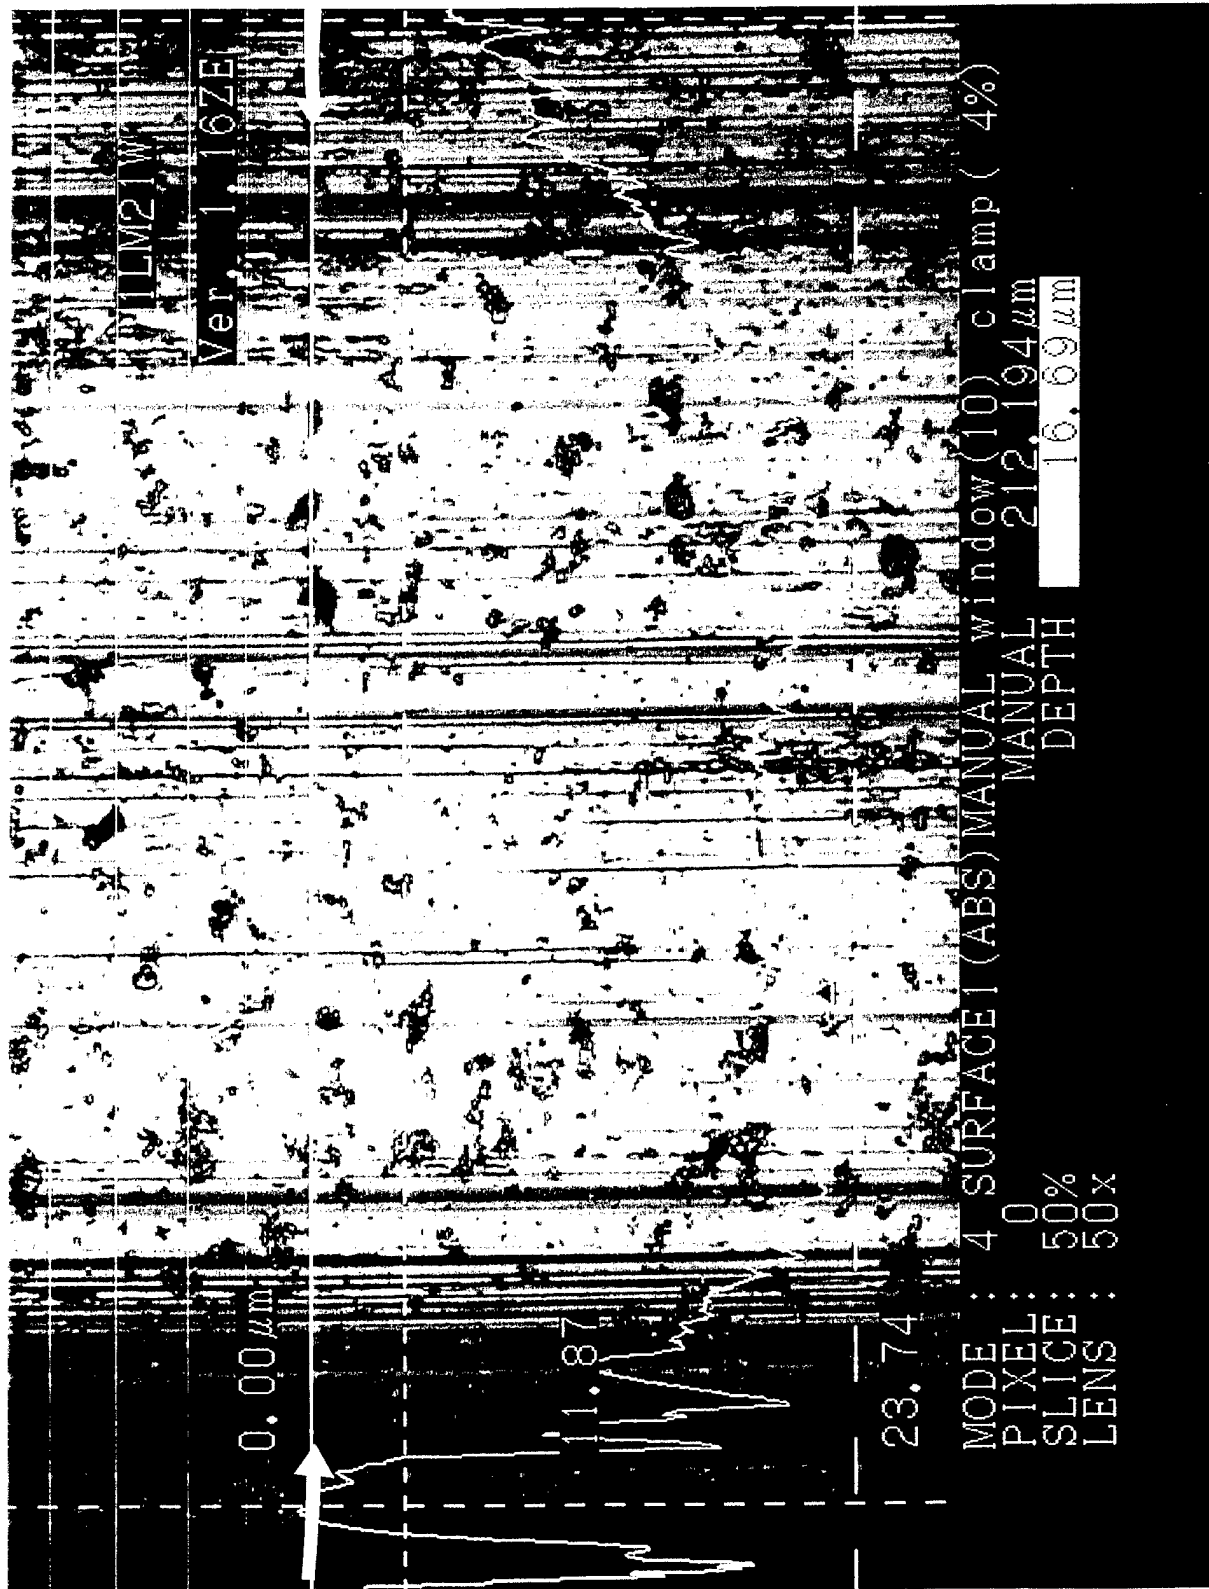
Figure 20. Lasertec Linear Scan Profile of SIK -00938 Rod Typical Thread Root (Mag. 1,250x).

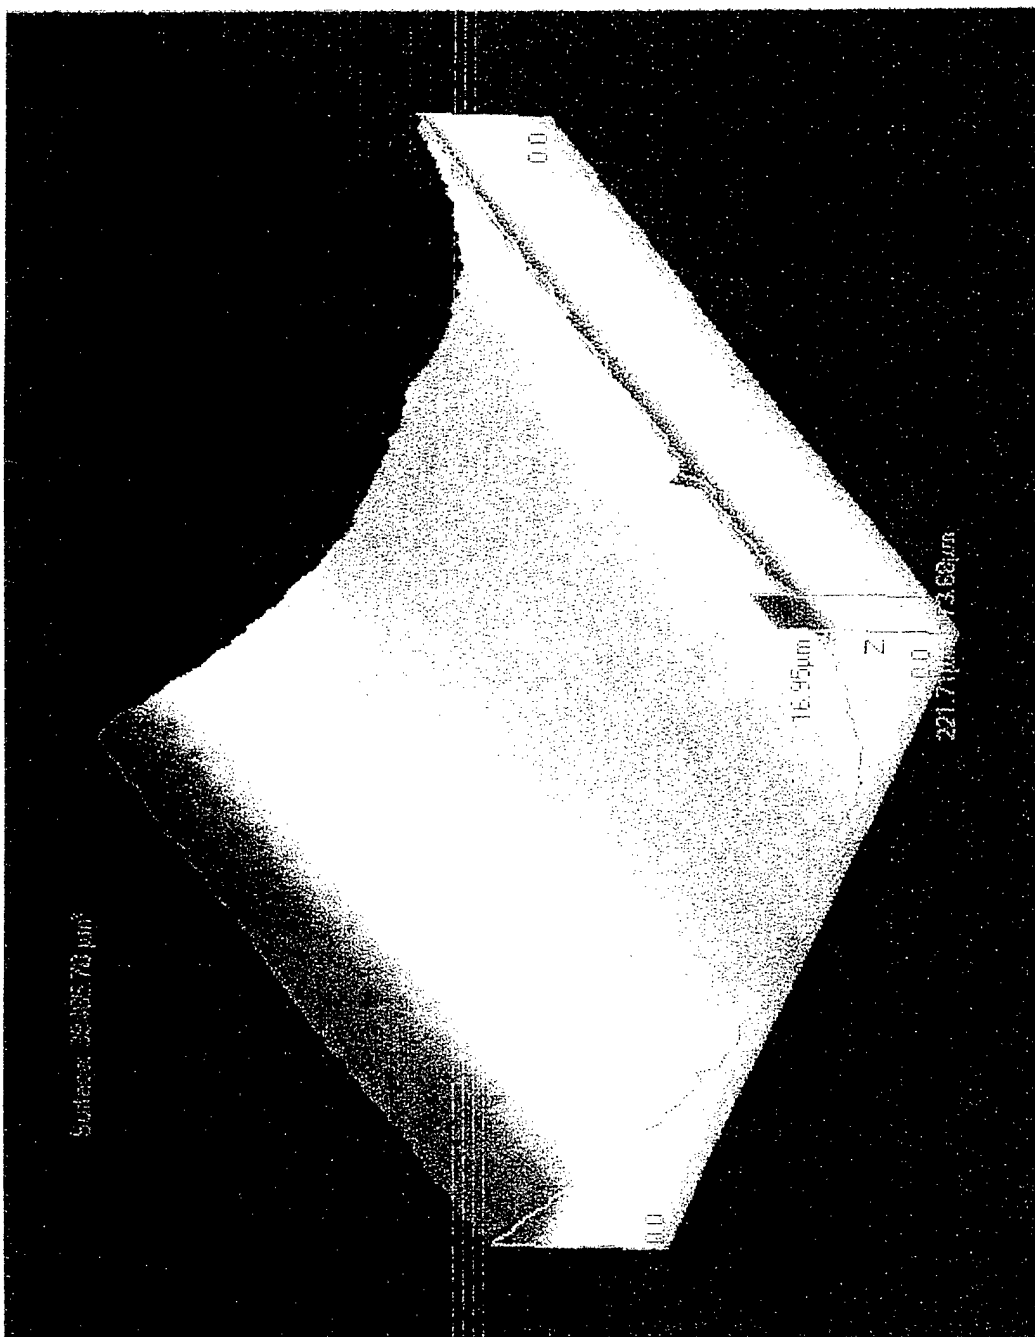
Figure 26. Color 3-D Scan of S&S Specimen -3 (Mag. 1,250x).

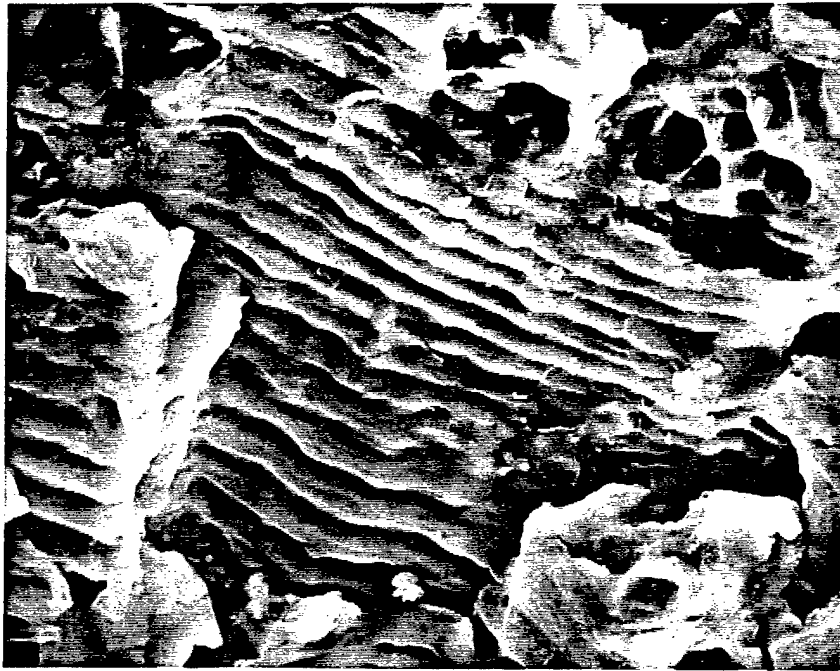
-2 and -3, respectively. As shown in Figure 56, the -00938 sample contained seven origins. One of the origins (right side of schematic) was on a different fracture plane than the remaining six origins. Fatigue progressed approximately 40% of the fracture surface as indicated by the transgranular fracture morphology, until final fast fracture occurred. This fast fracture was characterized by shear lips containing ductile dimples, indicative of tensile overload. Figures 62-70 are SEM micrographs that represent the fracture morphology of each of the regions illustrated in Figure 56. Figures 62 and 63 represent the origins, while Figure 64 shows the transgranular morphology characteristic of the fatigue zone. Figure 65 represents the fatigue and ductile interface, while Figure 66 represents typical striations on the fracture surface at low magnification. Figures 67-70 also represent the fatigue striations contained within the fracture surface at higher magnification.

Figure 70. Striations Noted on the Surface of SIK Rod -00938 (Mag. 5kx).

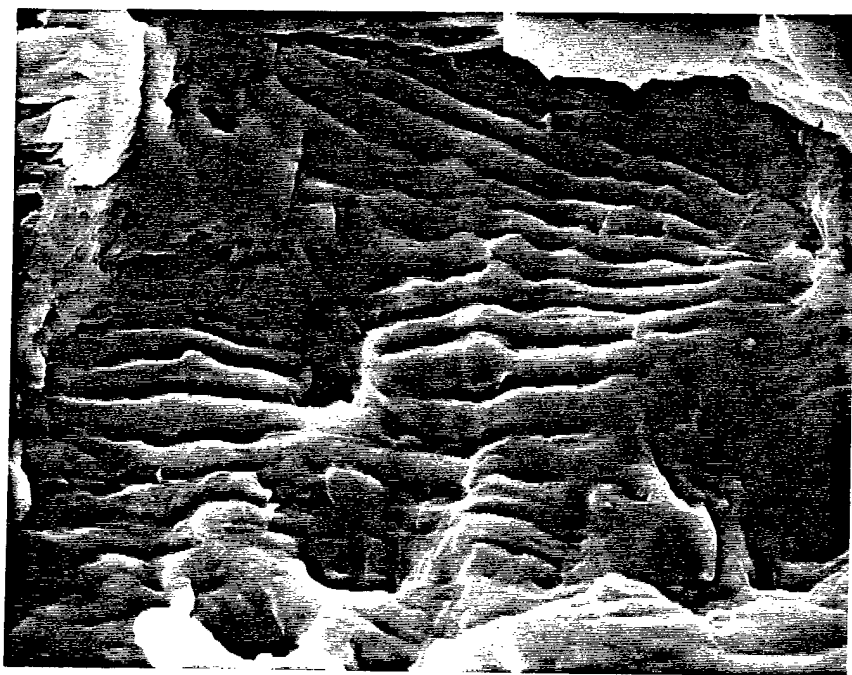
Figures 80–82 show low-magnification SEM micrographs of typical origins noted on the -174 fracture surface. Figures 83–86 represent the different morphologies noted on this fracture surface. Figure 82 shows the cyclic overload to shear transition region, while Figure 83 shows an example of cyclic overload. Figure 85 shows a cyclic overload morphology mixed with tearing, while Figure 86 is a morphology consisting of striations, tearing and ductility. Figures 87–91 represent the morphology within the fatigue regime.

Figure 89. Striations Noted Within the Fracture Surface of PUR Tie Rod -174 (Mag. 5kx).

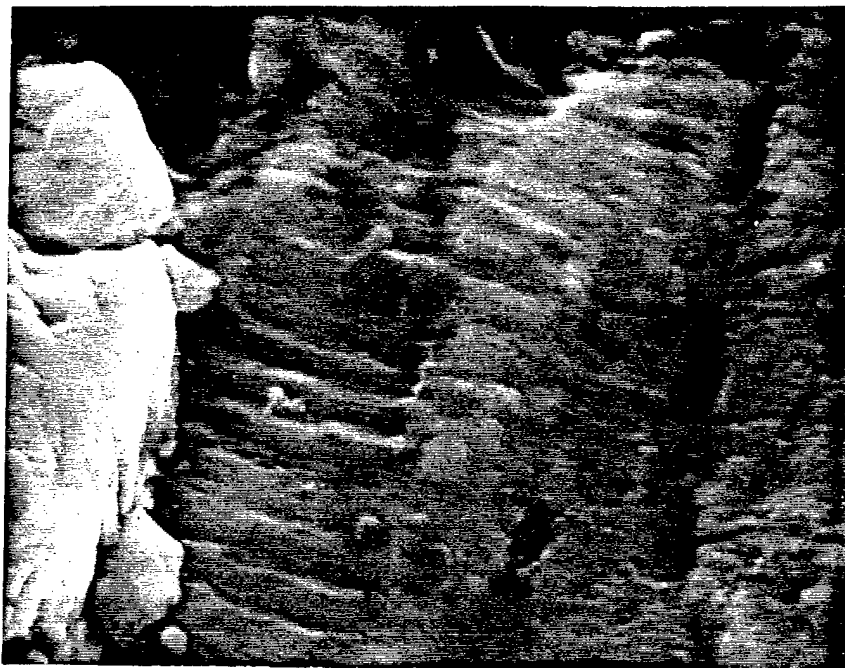
Figure 92 shows a low-magnification SEM micrograph of a typical origin noted on the PUR -177 fracture surface (Figure 59), while Figure 93 depicts the typical transgranular cyclic fatigue morphology. Figure 92 shows a morphology consisting of tearing with striations. Figure 94 shows a morphology consisting of tearing and a transgranular mode, as well as slight ductility. Figure 95 contains striations mixed with ductility, as well as cyclic overload, while Figure 96 shows ductile dimples with evidence of incremental loading. Figure 97 shows these ductile dimples at higher magnification. Figures 98–102 represent typical fatigue striation differences noted on the fracture surface of the PUR specimens.

Figure 98. Striations Noted on the Fracture Surface of PUR Rod -177 (Mag. 10kx).
